# Portable Appliance Testing Report

**Rewind Disco & Photobooths**

# Portable Appliance Test (PAT) Completion Certificate

APPLIANCE SUMMARY FOR Rewind Disco & Photobooths 27 Adelaide Street York YO23 1DL

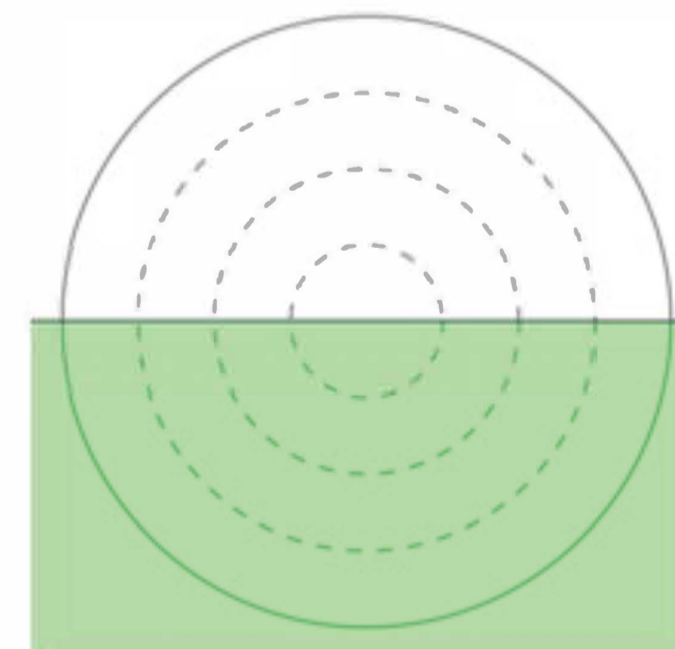
## PAT Test Summary

■ Appliances Passed    ■ Appliances Failed

Total Appliances

32

Appliances Passed

Appliances Failed

0
